SELLERS SURVEY REPORT

'SAMPLE' Gallart 13.50 Yacht

Location of Inspection: Cleopatra Marina, Preveza, Greece.

Carried out by: Steven Truss MIIMS Yacht Surveyor.

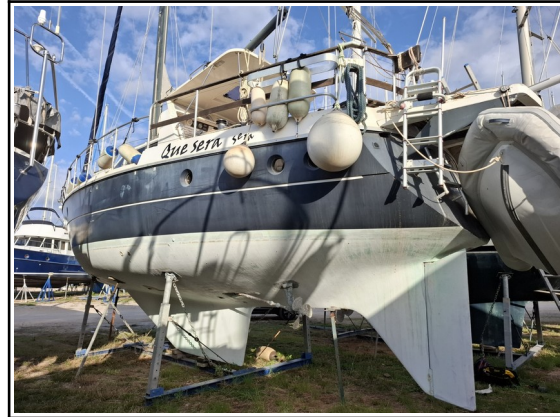
- The keel was sighted from various angles and found to be straight and true to the hull moulding.
- The keel had been coated with the same antifouling paint as the rest of the underwater hull which was in a fair condition.

- The keel was subjected to a visual inspection accompanied by light hammer soundings, which did not reveal any signs of damage along the sides, leading edge, or trailing edge. A limited visual examination of the keel's bottom surface found it to be fair, with no indications of grounding. However, in this particular design and construction, a small void or pocket exists at the aft end of the keel where no ballast is present. In this area, cosmetic damage to the fiberglass was observed. This damage is non-structural and can be addressed with a GRP (glass-reinforced plastic) repair at a convenient time. Recommendation. Although the observed fiberglass damage was cosmetic and did not compromise the structural integrity of the keel, it is advisable to carry out a GRP repair to prevent further deterioration. This should be scheduled during the next routine maintenance period to ensure ongoing protection against water ingress and to maintain the keel's overall condition.

- Externally, the curved section around the keel root was visually inspected and hammer tested with consistent, robust soundings returned.
- Moisture readings close by the keel in the flat sections forward and aft on the hull were not different to anywhere else on the underwater hull. Externally there was no evidence of any significant corrosion or staining.

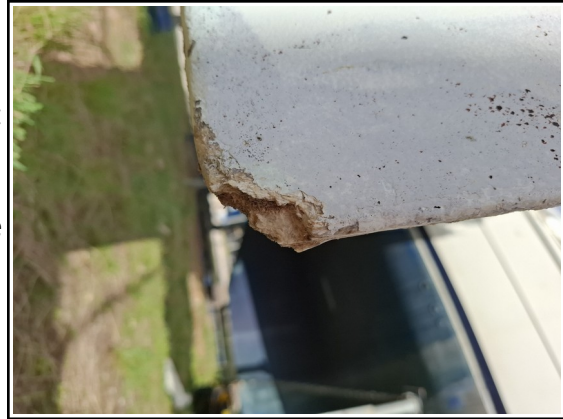
- The wheels were tried hard over to hard over and found in a good, smooth operational condition and to sit correctly on the stops.
- Force was applied to the rudder blade to test the bearings for wear with none found.

- The stock was mostly unsighted however no evidence of pitting was noticed around the neck of the stock which entered the vessel.
- The coatings on the rudder were found to be in satisfactory condition. Minor gelcoat damage was observed at the lower end of the rudder, but this was not a cause for concern. These cosmetic issues can be easily repaired prior to relaunch. Recommendation. Although the gelcoat damage was superficial, it is advisable to carry out the necessary repairs before relaunching the vessel. This will help maintain the rudder's protection against water ingress and prevent further wear over time.

- The rudders profile was found satisfactory and the rudder was found true to the centreline of the hull.
- The emergency steering system was in place and checked.

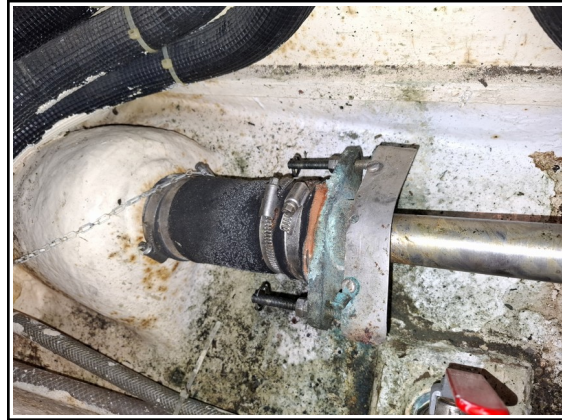
- The propellers were lightly sound tested and the ring revealed a good tone suggesting the bronze was still in a good condition.
- Reasonable force was applied to the struts which were found secure and in a serviceable condition.
- The cutlass type shaft bearings were secure and adequate.
- The stainless steel shafts were free of any significant corrosion or staining and sighted as being straight when rotated. When tested with a magnet they were found to be non magnetic. This along with the other visual evidence would suggest that they were made of 316 type stainless steel.

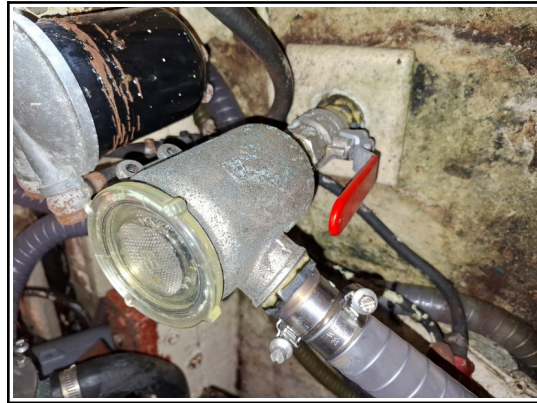
- No evidence of continuous leakage was found in the vicinity of the valves.
- Vigorous force was applied to the valve assemblies and adjacent pipework and all accessible valve bodies were found to be secure.
- All strainers were found in a serviceable condition.
- The bodies of the valves were in a serviceable condition.
- The skin fittings around the transom and topsides appeared to be sound where examined externally and were considered to be at a reasonable height. Cockpit drainage was functional and as original.
- Although it was not possible to survey all the associated pipework in detail such as I was able to inspect appeared satisfactory with the connections and worm drives clamps in a serviceable condition.

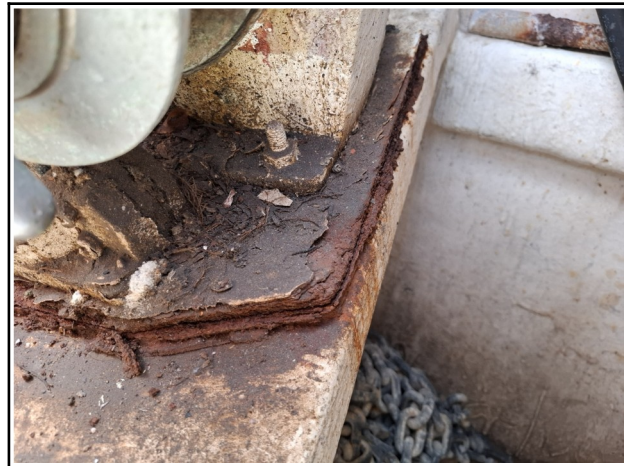
- The bow anchor chain was sample inspected and found to be in a fair condition generally.
- The bitter end could be seen to be attached to an anchor point inside the locker with a length of lashing.

- The anchor windlass was not tested, and the base plate for the winch exhibited significant corrosion. It is recommended that this corrosion be monitored closely to prevent potential failure or further deterioration. Recommendation. Schedule regular inspections of the windlass and its base plate, particularly focusing on signs of further corrosion. Consider conducting a functional test of the anchor windlass during the next maintenance period to ensure its operational reliability. If corrosion progresses, timely repairs or replacements should be planned to maintain safety and functionality.

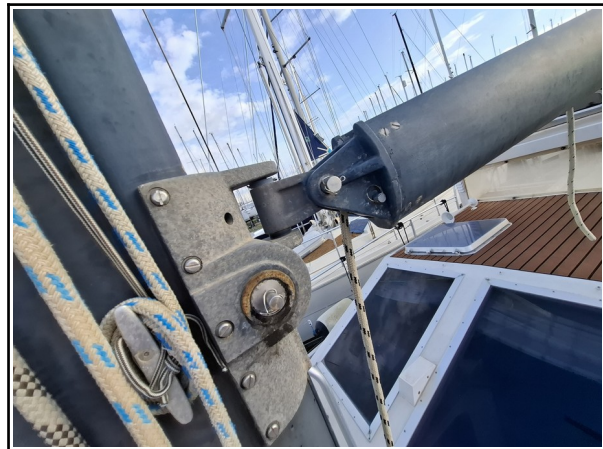
- The black powder coated aluminium anodising was found to be in a good condition. No cracks or distortion in the mast were found. No corrosion was found around stainless fittings.
- The gooseneck fitting was a cast steel fitting in a good condition and attached to the mast with stainless steel screws. The mast foot plate was found in a good condition and free from cracks and distortion.

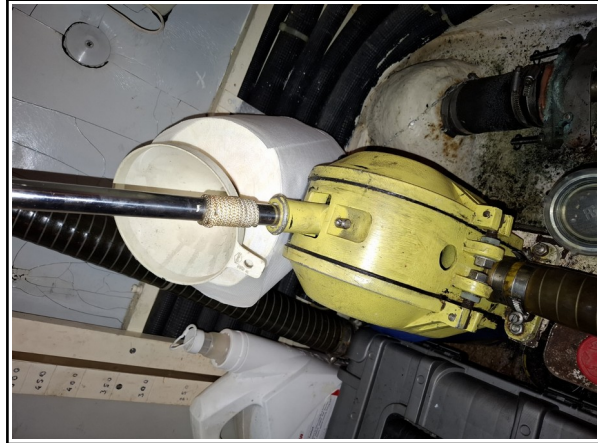
- The handle for the fixed pumps were found and the pumps were tested and suction could be heard and were proven to operate correctly.
- The pipework was found to be serviceable and the end of the pipe fitted with a strum box which appeared to be correctly secured within the bilge.

- The forward electric pump located in the bilge was tested and determined to be faulty, as it tripped the DC panel during the assessment. Additionally, the owner reported that the main electric pump is also non-operational; plans are in place for its repair prior to relaunching the vessel.

- Recommendations. Repairs: Prioritise the repair of both the forward and main electric pumps to ensure they meet operational standards before the vessel is relaunched. Preventive Maintenance: Establish a regular maintenance schedule for all pumps on board, including periodic testing and inspections, to prevent future failures and ensure the safety of the vessel.

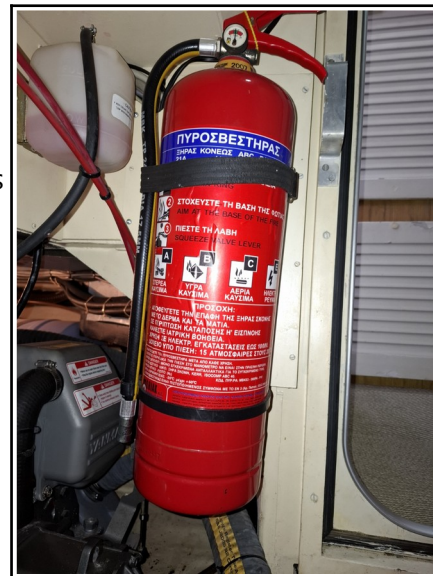
- The fire extinguishers appeared to be in a serviceable condition and secured to the bulkheads ready for immediate use.

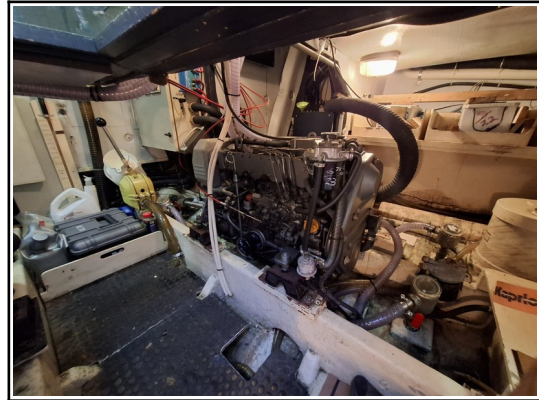
- The control panel was found to be in visually serviceable condition.
- The alternator belts were tight in good order.
- The 12 Volt alternators were securely mounted and the connections secure and well made.

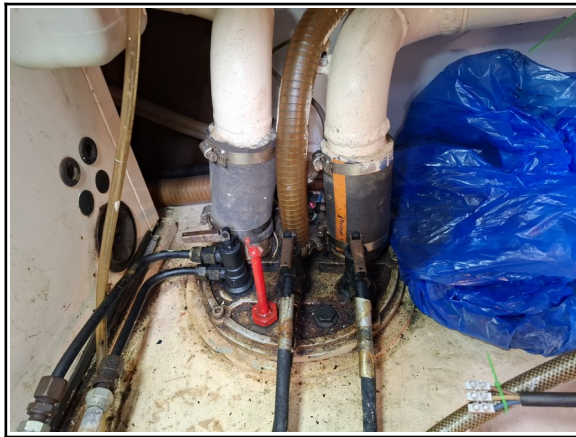
The vessel was fitted with one free standing fuel oil tank of GRP construction which was examined as far as practical (but not pressure tested) and found externally in a good condition. The tank was not filled up and it was not possible to check fully its oil tight integrity and this is not guaranteed.

- All flexible hoses were found to be in good condition and primarily compliant with ISO 7840 standards. It is recommended that the copper fuel pipes be properly secured to prevent any undue movement or potential wear.
- The filters were found in serviceable order and free from leaks.
- The tank was found secure and in a good cosmetic condition where accessible with no leakage evident in their sighted area.
