PRE-PURCHASE SURVEY REPORT

'Ganesha' Amel 54 Yacht

Date of Inspection: 08/01/2024.

Location of Inspection: Cleopatra Marina, Preveza, Greece.

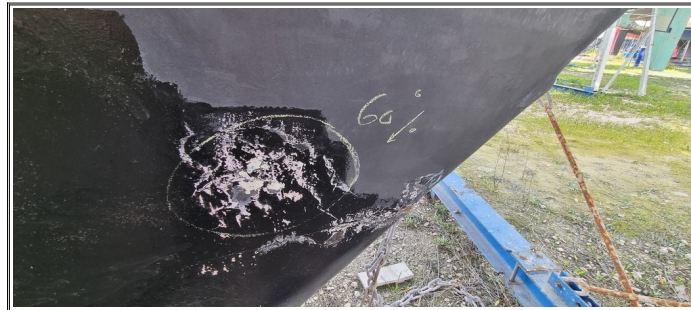
An area of gelcoat damage on the starboard side of the keel / forwards was noted. Based on these findings, it is recommended that the area with gelcoat damage undergoes thorough repair. This should include drying out the area to ensure moisture levels are

reduced before applying a new gelcoat layer. Proper drying is essential to prevent the trapping of moisture, which could exacerbate the problem over time. After the repair, it is advisable to conduct another moisture meter reading to confirm the effectiveness of the drying process.

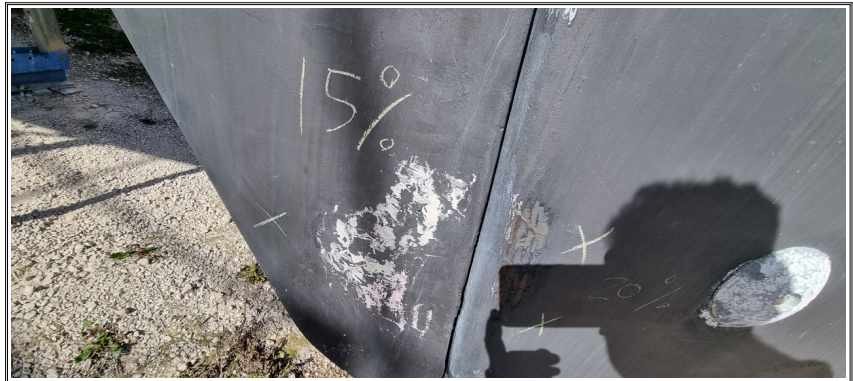
- The stock was sighted from a distance and no evidence of pitting was noticed around the neck of the stock which entered the vessel.
- The inspection of the coatings on the rudder indicated that they were generally satisfactory, showcasing an adequate level of maintenance and protection against the marine environment. However, during the examination, two small cracks were identified at the heel of the rudder (P), a finding that warrants attention due to the potential for water ingress and subsequent internal damage. Additionally, high moisture meter readings were recorded in the vicinity of the cracks. High moisture levels within the rudder can compromise its structural integrity over time, leading to more severe issues such as delamination or internal corrosion of metal components, if present. These findings suggest that water may have penetrated through the cracks, emphasizing the need for action to prevent further degradation. The adjoining skag also presented some concerns, with light gelcoat damage noted on the lower port side. Gelcoat damage, while often superficial, can serve as a pathway for moisture ingress, especially if left unaddressed in areas exposed to constant water contact.

Given the observations detailed on page 12 regarding the condition of the rudder and skag, it is crucial to initiate a comprehensive repair process. This process should commence with the drying out of the affected areas to ensure the moisture content is reduced to acceptable levels. Following this, the identified cracks and gelcoat damage should be addressed and repaired.

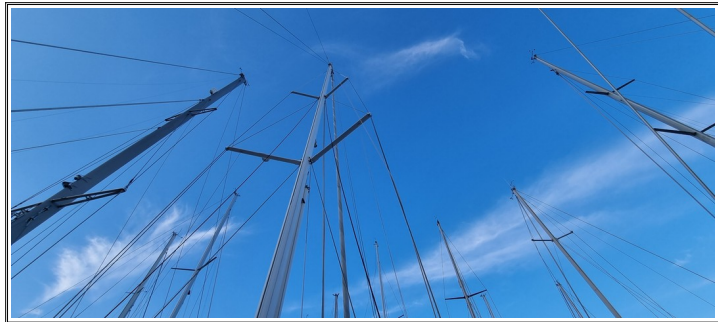
- The aluminium anodising on the masts was found to be in a good condition. No cracks or distortion in the masts were found. No corrosion was found around stainless fittings.
- The gooseneck fittings were cast alloy fittings and attached to the masts with bolts. The mast foot plates were found in a serviceable condition and free from cracks and distortion. The jockey pole was seen secured. There was a small crack in the lower sleeve which should be monitored when in use.

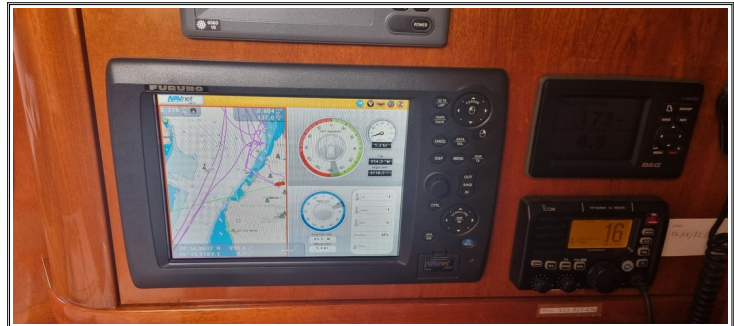
- The binnacle compass appeared to be correctly filled with fluid.
- GPS Furuno GP 150 – switched on and display damaged.
- 12" Navnet 3D screen – switched on and display damaged.
- Furuno GPS + AIS FA 50 antenna – switched on and display damaged.
- B&G Hydra 3000 Multi – switched on and display damaged.
- Furuno 1832 radar – switched on and display damaged.
- VHF ICOM IC-M506 plus handheld spare. (battery required) – switched on and display damaged.
- Auto pilot x 2 – tested and operating.
