SELLERS SURVEY REPORT

'SAMPLE' Gallart 13.50 Yacht

Location of Inspection: Cleopatra Marina, Preveza, Greece.

Carried out by: Steven Truss MIIMS Yacht Surveyor.

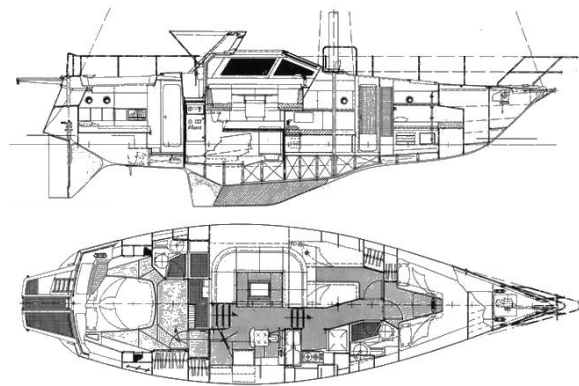
3) KEEL

The keel was of the encapsulated type, consisting of internal steel or lead ballast, which was fully integrated and fibreglassed to the hull molding. While the vessel was ashore and chocked, the keel was observed to be in compression against the hull. The following comments were based on an inspection conducted under these specific conditions.

- The keel was sighted from various angles and found to be straight and true to the hull moulding.
- The keel had been coated with the same antifouling paint as the rest of the underwater hull which was in a fair condition.

- The keel was subjected to a visual inspection accompanied by light hammer soundings, which did not reveal any signs of damage along the sides, leading edge, or trailing edge. A limited visual examination of the keel's bottom surface found it to be fair, with no indications of grounding. However, in this particular design and construction, a small void or pocket exists at the aft end of the keel where no ballast is present. In this area, cosmetic damage to the fiberglass was observed. This damage is non-structural and can be addressed with a GRP (glass-reinforced plastic) repair at a convenient time. Recommendation. Although the observed fiberglass damage was cosmetic and did not compromise the structural integrity of the keel, it is advisable to carry out a GRP repair to prevent further deterioration. This should be scheduled during the next routine maintenance period to ensure ongoing protection against water ingress and to maintain the keel's overall condition.

- Externally, the curved section around the keel root was visually inspected and hammer tested with consistent, robust soundings returned.
- Moisture readings close by the keel in the flat sections forward and aft on the hull were not different to anywhere else on the underwater hull. Externally there was no evidence of any significant corrosion or staining.

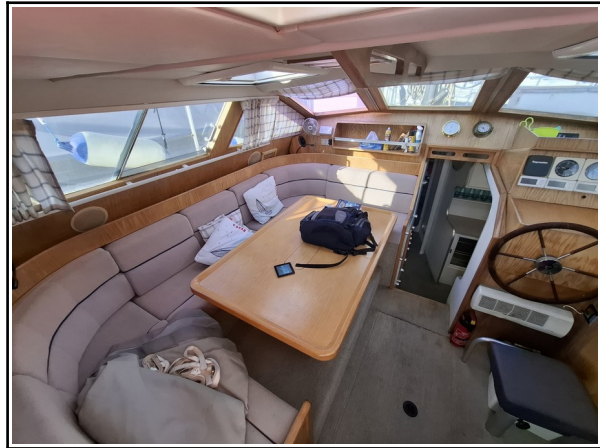
29) GENERAL ACCOMMODATION

The accommodation was found in satisfactory standard with no modification made from the manufacturers design. Cosmetically the interior of the vessel was in a good condition.

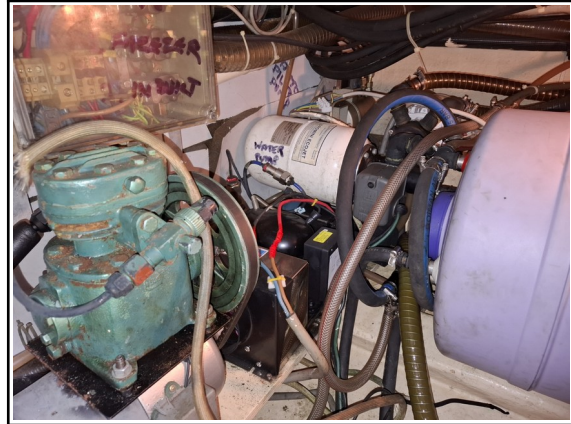
- All piping that was accessible and visibly inspected was satisfactory clipped and secure.
- The water pump was tested and heard to operate.
- The tanks were securely fixed down and where access was available were found in serviceable condition.
- All internal taps were functioning correctly.
- The hot water tank immersion heater was inspected and found to be in good condition, with no visible signs of corrosion, leakage, or wear on the external components. Electrical connections appeared secure, and the overall installation was in compliance with standard safety guidelines.

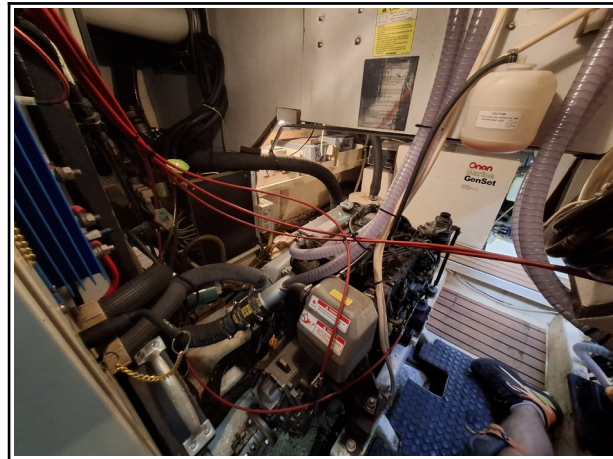
33) ELECTRICAL INSTALLATION

The electrical system consisted of four 12V domestic batteries and one dedicated engine battery, divided into two banks: one designated for engine starting and the others providing power for the domestic supply. In addition to the 12V DC system, a 220V AC shore power system was installed, providing power to cabin outlets. Shore power enters the vessel through a plug and socket mounted on the cockpit side, leading to an RCD-protected consumer unit located in the cabin. This unit distributes AC power to the battery charger and various outlet sockets throughout the vessel, ensuring safe and reliable onboard power management.

Solar panels, Onan genset and an inverter system were also observed during the inspection and found to be in serviceable condition. The solar panels provided an additional renewable power source for charging the batteries, while the inverter system efficiently converts the stored 12V DC power to 220V AC for use with onboard appliances. Both systems contribute to the vessel's energy efficiency and independence, particularly during extended periods away from shore power. Regular checks are recommended to ensure continued optimal performance of the generator.
