PRE-PURCHASE SURVEY REPORT

'Ganesha' Amel 54 Yacht

Date of Inspection: 08/01/2024.

Location of Inspection: Cleopatra Marina, Preveza, Greece.

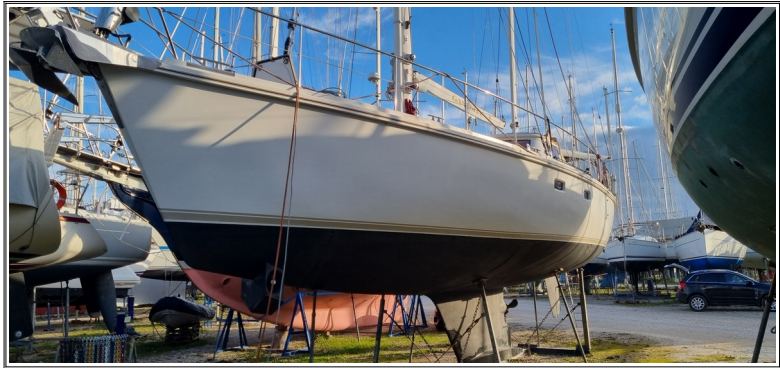
- Further inspection involved visual assessment and light hammer soundings, a standard practice in marine surveys to detect anomalies beneath the surface that are not visible to the eye. This technique revealed an area of gelcoat damage on the starboard side of the keel. Gelcoat damage, while often cosmetic, can lead to more significant issues if water penetrates the laminate, causing osmosis or structural weakening over time. Additionally, the inspection employed a moisture meter, which indicated higher moisture readings of 60% in the damaged area. High moisture levels in the fiberglass can be a precursor to potential laminate deterioration.

An area of gelcoat damage on the starboard side of the keel / forwards was noted. Based on these findings, it is recommended that the area with gelcoat damage undergoes thorough repair. This should include drying out the area to ensure moisture levels are

reduced before applying a new gelcoat layer. Proper drying is essential to prevent the trapping of moisture, which could exacerbate the problem over time. After the repair, it is advisable to conduct another moisture meter reading to confirm the effectiveness of the drying process.

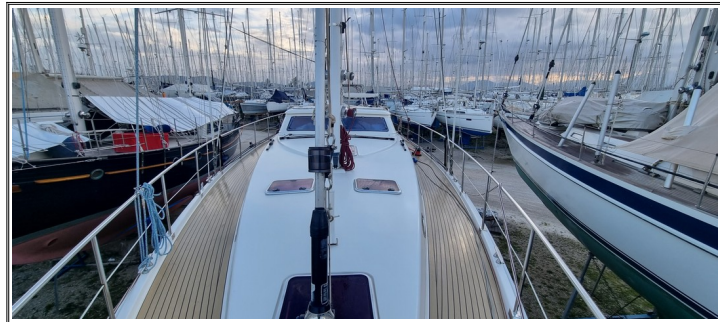
- Moisture meter readings were taken on the topsides as a comparison against the underbody. The meter readings were from 12 to 15 on the shallow scale and 13 to 15 on the deep. All these readings were within acceptable levels and currently not of concern.
- The topsides and transom were closely inspected for any deformation, cracks or crazing and apart from the usual marks that were light in nature and cosmetic defects, the sides were structurally sound.
- The gelcoat was found to have a good lustre and be in good order with only a few cosmetic blemishes noted.

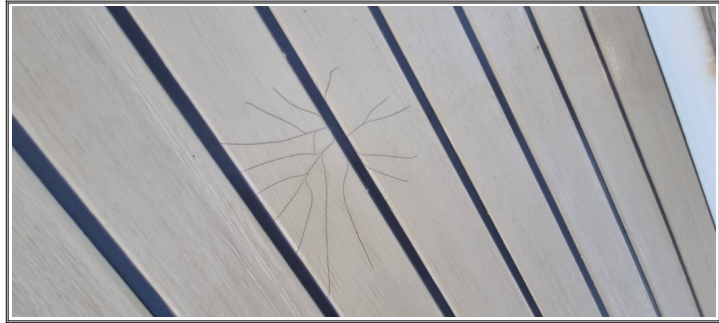
- The entire deck, coachroof and upper helm walkways were found firm underfoot with no significant flexing detected.
- The moisture readings were well within acceptable limits 10 – 12 and for all practicable purposes were regarded as dry.

- Hammer sounding returns did not reveal any evidence of significant voids or delamination.
- The visual inspection of the decks, coachroof, and cockpit was conducted meticulously to assess their condition. This examination did not uncover any significant areas of stress cracks or damage, indicating a generally sound structural integrity of these components. However, a minimal number of small star crazes were observed on the foredeck. It is important to note that these crazes were of a non-structural nature and, as such, do not pose a significant concern regarding the vessel's overall safety and durability.

- The cockpit sole was found to be firm under the weight of the surveyor. There were no signs of significant crazing or other damage, with moisture meter readings satisfactory.

- The wheel pedestal was integral to the cockpit mould and found in a good condition along with the table. Hinged deck hatches gave access for storage and gas tanks.

- Areas of stress such as around rigging attachment points showed no signs of flex or delamination.

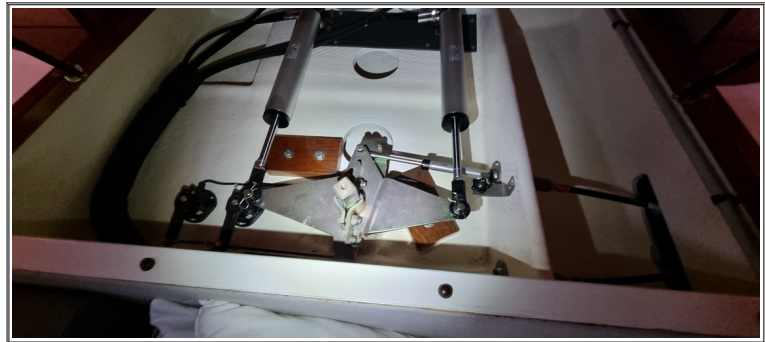
- The stock was sighted from a distance and no evidence of pitting was noticed around the neck of the stock which entered the vessel.
- The inspection of the coatings on the rudder indicated that they were generally satisfactory, showcasing an adequate level of maintenance and protection against the marine environment. However, during the examination, two small cracks were identified at the heel of the rudder (P), a finding that warrants attention due to the potential for water ingress and subsequent internal damage. Additionally, high moisture meter readings were recorded in the vicinity of the cracks. High moisture levels within the rudder can compromise its structural integrity over time, leading to more severe issues such as delamination or internal corrosion of metal components, if present. These findings suggest that water may have penetrated through the cracks, emphasizing the need for action to prevent further degradation. The adjoining skag also presented some concerns, with light gelcoat damage noted on the lower port side. Gelcoat damage, while often superficial, can serve as a pathway for moisture ingress, especially if left unaddressed in areas exposed to constant water contact.

- The rudders profile was found satisfactory and the rudder was found true to the centreline of the hull. The emergency steering system was in place but not tested. The auto pilot appeared to be working.

Given the observations detailed on page 12 regarding the condition of the rudder and skag, it is crucial to initiate a comprehensive repair process. This process should commence with the drying out of the affected areas to ensure the moisture content is reduced to acceptable levels. Following this, the identified cracks and gelcoat damage should be addressed and repaired.

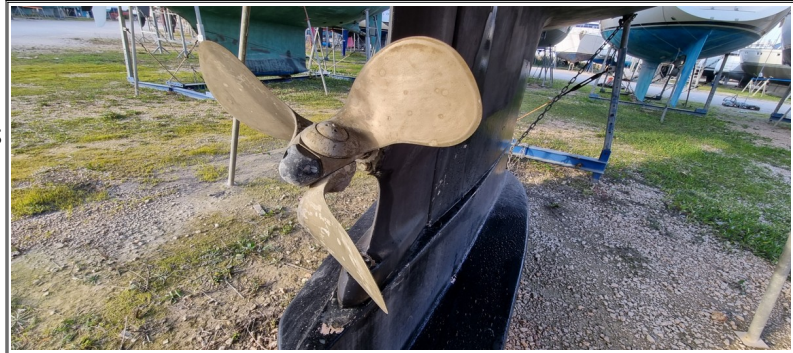
- The C drive was found in a good condition with the gearbox coupling correctly through bolted to the gearbox.

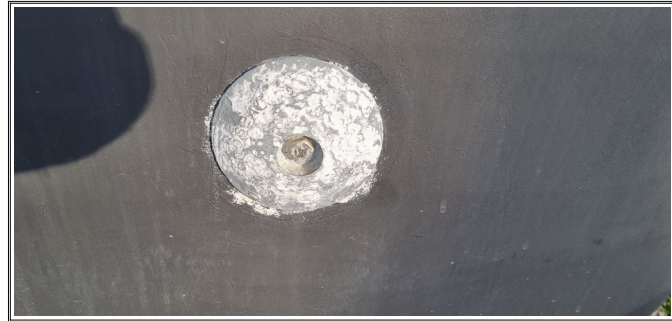
Two zinc rudder anodes and one propeller anode held sufficient mass for on going protection.

The additional hull anode / grounding plate was inside the hull properly bonded to the engines stern gear seat, and to various overboard discharges by a clearly marked multi stranded earth wire of about 4mm square. The copper strip / bonding was examined as far as practicable limitations of access allowed and was found generally in a fair condition.

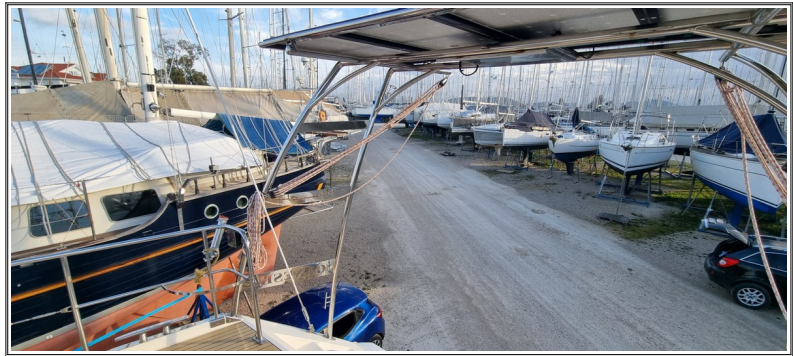
- No defects were found in any of the attachment points.
- All bolts were tight and secure.
- The pulpit and pushpits were found in serviceable condition with no visible damage. All stanchion bases were found secure and in a serviceable condition.
- The stainless steel arch, which was securely fitted to the transom of the vessel, served a dual purpose by providing robust support for both the solar panels and the dinghy. This configuration not only maximised the utility of the available space but also enhanced the vessel's self-sufficiency and operational capability. Supporting the dinghy via the stainless steel arch was a practical solution for dinghy storage, allowing for easy deployment and retrieval while minimising the deck space used. This setup is particularly advantageous for cruising and long passages, where efficient use of space and accessibility are paramount.

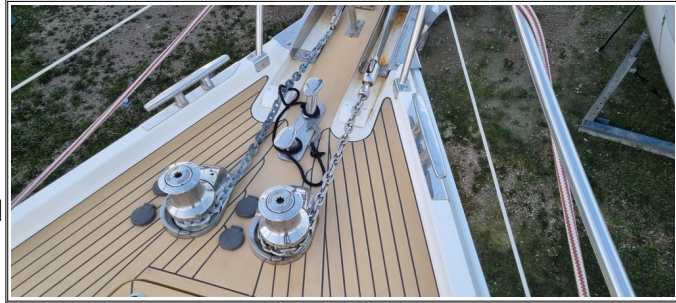
- The main anchor was considered to be a suitable minimum weight for this type of vessel for sheltered waters and found to be in serviceable condition.
- The chains were found attached to the anchors by steel swivel shackles found in a good condition and not bent.
- The stem head fittings with the bow rollers were found secure.
- The bitter end of the chains were attached to an anchor point inside the locker with a length of lashing.
- The anchor windlass's were found securely mounted and tested to operate from the helm.
- The anchor locker hatch was found to be in serviceable condition and securely held in position with a latch. The locker itself was of a suitable size and well drained.
- All cleats were found securely mounted.
- A selection of fenders and warps were found onboard.

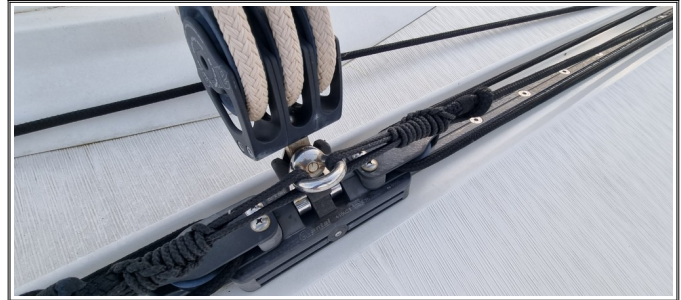
- All winches were rotated by hand and / or electric and were secured to the decks and were in a serviceable condition.
- No significant wear or UV degrading was found on the blocks and sheaves.
- Genoa tracks were secure and tight to the side decks / toerails.
- Genoa cars both on the port and starboard side decks were free moving up and down the track.
- The main sheet track, car and tackle were found in serviceable order.
- Rope jammers were free moving but were not all fully tested under any load.
- An electrically operated boarding ladder was fitted to the transom platform thus enabling a person who has fallen into the water a way of re-boarding the vessel.
- 5 ST winches, including 3 electric all working.

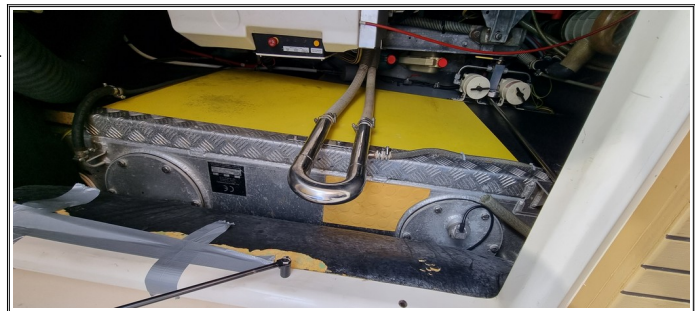
The vessel was equipped with a single free-standing fuel oil tank, constructed from aluminium metal, which was inspected to the extent feasible. Upon examination, the tank was found to be in a satisfactory original condition.

- All flexible fuel hoses were found in a good condition and identified as being to ISO 7840 standards.
- The filters were found in serviceable order and free from leaks.
- The tank was found secure and where accessible in a good cosmetic condition with no leakage evident in their sighted areas.
- The filling pipe was taken to deck level and was so arranged that they were not possible for fuel to overflow into the vessels hull or bilge. No checking of the deck connection seals were carried out.
- The vent pipe opening was furnished with an effective flame arrestor and the end of the pipe was fitted in a position where no danger would occur from escaping fuel or vapour.
- An emergency fuel shut off cock was correctly fitted at the tank end and was operable from inside the yacht.

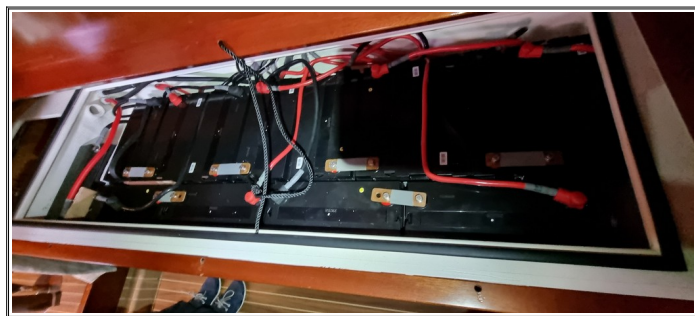
- The engine and domestic batteries underwent testing, with the voltage measurements recorded indicating that they were fully charged. This finding suggests that the batteries are in a good state of health, capable of providing the necessary power for both the engine's starting requirements and the vessel's domestic electrical needs.
- Ventilation to the batteries was seen to be adequate.

- All cables were securely clamped to the battery terminals.
- All batteries were found secured in place within the confines of the storage lockers.
- The wiring was PVC insulated, and in the *limited* places for inspection, the wiring was adequately clipped up and fitted where necessary with bulkhead glands and crimped end fittings. The cable sizes appeared to be adequate for the circuits examined and the DC cables were all of the multi-strand type.
- The DC system was fitted with a master isolator switch and it was considered to be installed as close to the batteries as practicable.
- The 220 volt system was plugged into shore power and the system was functional and was properly protected by an RCD breaker. The main shore power lead was seen to be serviceable.
- The battery charger was seen to be neatly installed and in reasonable cosmetic condition and proven serviceable.

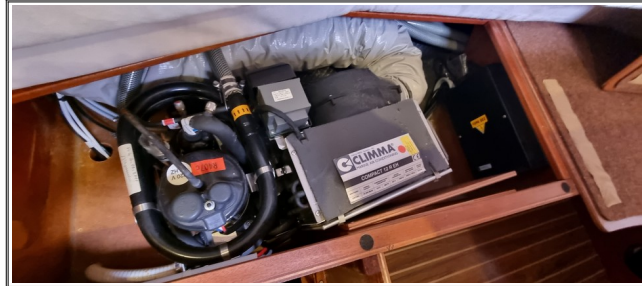
Two air conditioning units were identified onboard, which were supplied with seawater from a large pump situated in the engine bay. Although it was not feasible to test these units with the vessel ashore, they appeared to be in a serviceable and working condition. This observation is based on a visual inspection and the general state of the units and their components. Despite the lack of operational testing at the time of survey, the units' condition suggests that they were maintained and likely to perform as expected when in use.

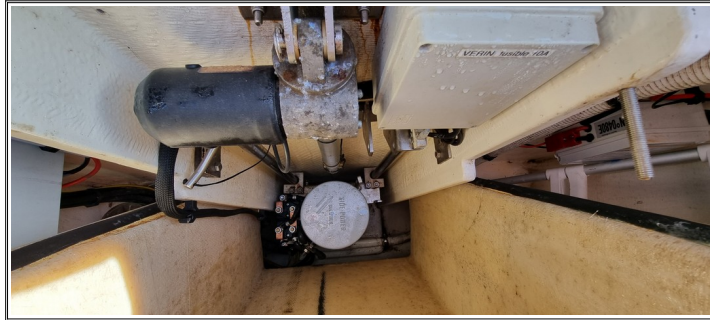
The bow thruster installation underwent a visual inspection and was determined to have been competently installed, appointed, and found to be appropriate. The isolator, situated in the anchor locker was properly secured. All components of the system, accessible without the need for removal of bulkheads, panels, or similar barriers, were meticulously examined. Considerable efforts were undertaken to ascertain the system's installation compliance in comparison with similar existing systems. The system has been sensibly installed and was ascertained to be in good operating condition.
